BC MINISTRY OF WATER, LAND AND RESOURCE STEWARDSHIP

NICOLA POST 2019 - 2021 FLOOD AND WILDFIRE: HYDROLOGY LITERATURE REVIEW

Ministry Contract: GS25LUS0021
MJ Milne & Associates File: WL1-002
Polar File: 1480101
FINAL REPORT
March 2025

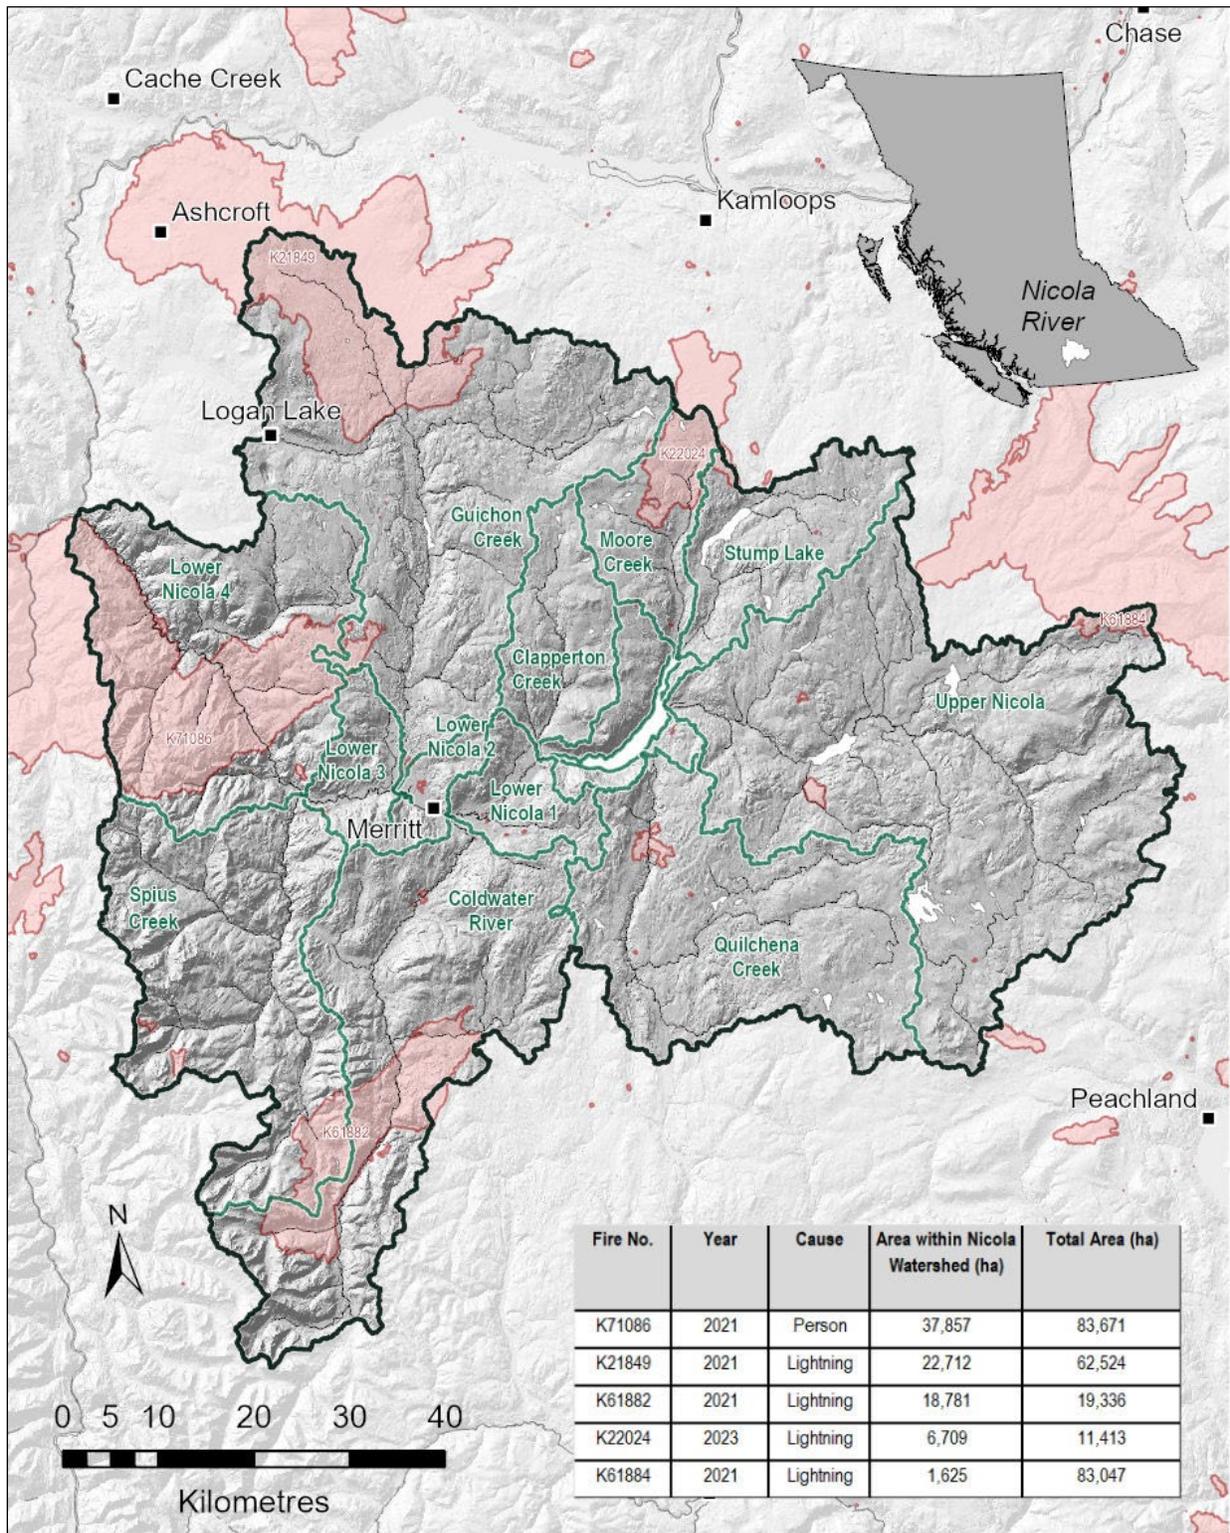
FIGURE 1.1 *Nicola River Watershed and location of wildfires that occurred since 2019. Wildfires larger than 1,000 ha are identified.*

Milne and Polar were retained by WLRS to provide this update in response to the major flooding in November 2021 and several wildfires since 2019 (FIGURE 1.1). WLRS is concerned that these disturbances have altered watershed conditions, and thus may have affected some conclusions and recommendations identified within the State of the Watershed reports noted above. This report is intended to answer one key question: “What has changed in the Nicola River watershed post-fire and post-flood?”

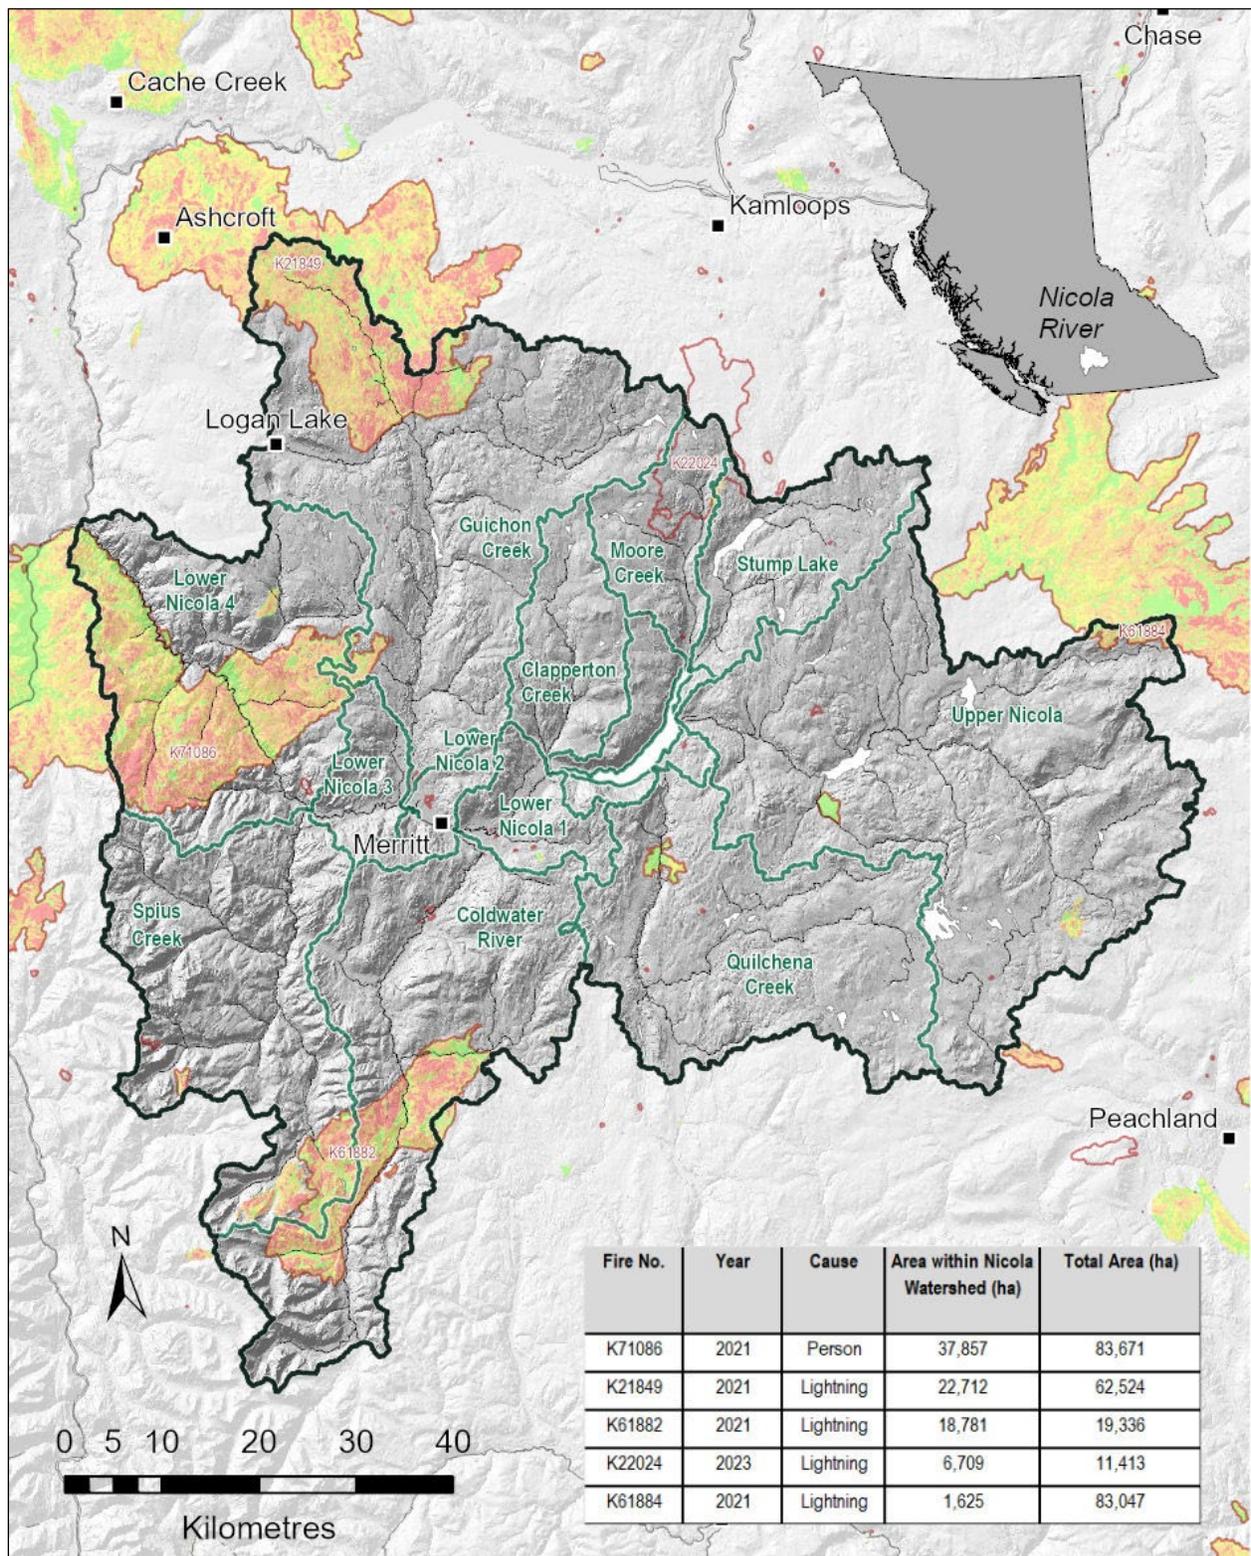
FIGURE 1.2 Nicola River Watershed showing the available burn severity mapping for wildfires that occurred since 2019 (Province of British Columbia, 2025b). Wildfires larger than 1,000 ha are identified.

As shown in TABLE 1.5 and FIGURE 1.2, provincial vegetation burn severity mapping is available for four of the five largest wildfires affecting the Nicola Watershed since 2019 (Province of British Columbia, 2025b). The Lytton Wildfire (K71086) was the largest covering an area of nearly 38,000 ha (~5% of the watershed). About 20% of this overall area had high or moderate burn severity, with much of this located in the Lower Nicola 4 residual unit⁴, where nearly 40% was identified as high or moderate burn severity. The Tremont Creek Wildfire (K21849) affected about 20,000 ha of the upper reaches of Guichon Creek, where 37% was mapped as high or moderate burn severity. The July Mountain Wildfire (K61882) affected nearly 19,000 ha of the Nicola Watershed, covering about 14,000 ha in the Coldwater River and 5,000 ha in the Spius Creek catchments. High and moderate burn severity totalled 44% and 39% in each of these catchments, respectively. Although the White Rock Lake Wildfire (K61884) affected over 83,000 ha, the vast majority of it was outside the Nicola Watershed. Only about 1,200 ha was located within the Upper Nicola watershed unit, with about 350 ha classed as high or moderate burn severity.

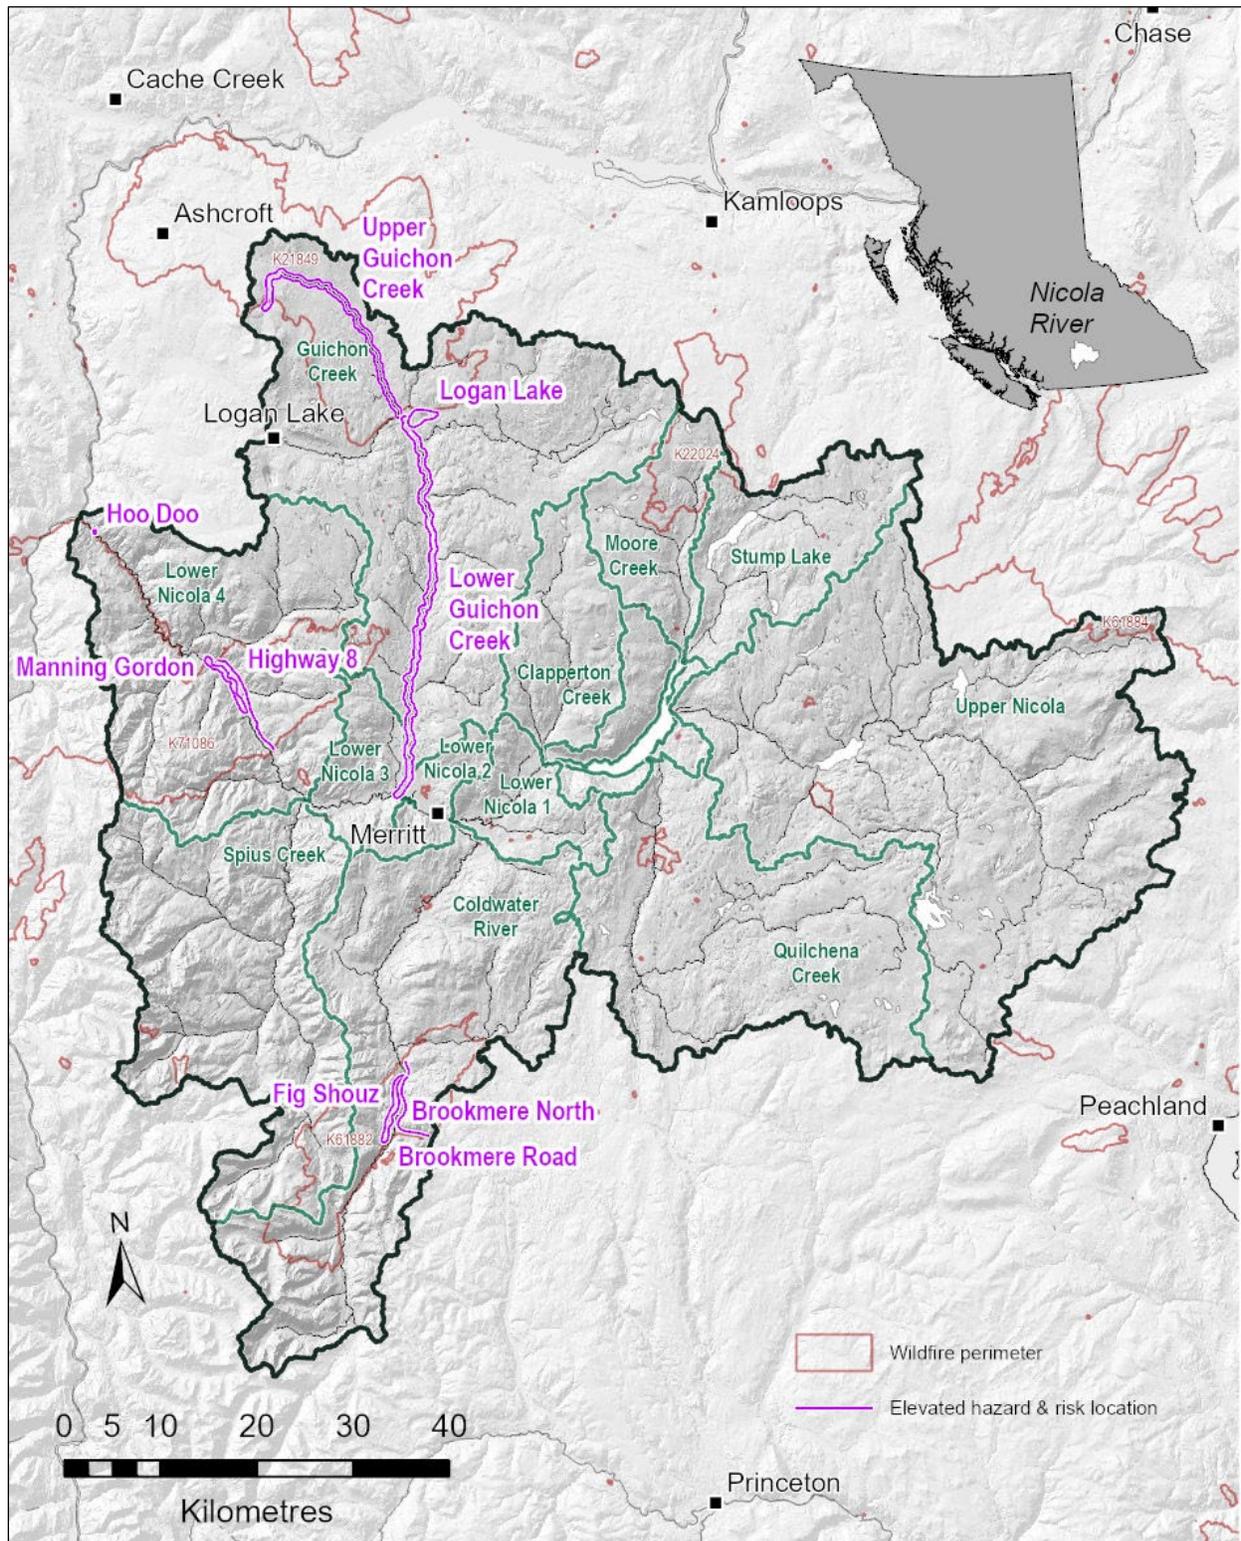
FIGURE 4.1 *Nicola River Watershed and locations identified with elevated post-wildfire hazard and/or risk.*

Post wildfire hazard and risk assessments are summarized in the following section. Reconnaissance level assessments were completed for the four largest fires discussed in this report, and more detailed assessments were completed for two areas in the Lytton fire. Areas with elevated hazard and/or risk were identified in all of the reports, some outside of the Nicola River watershed. Areas of actual or potential elevated hazard or risk are shown in FIGURE 4.1.
